UNITED STATES COAST GUARD

INVESTIGATION INTO THE S/V KIELE V DISMASTING AND PERSONNEL CASUALTY

ON 03/25/2007

Coast Guard Summary of Investigation:
S/V KIELE V (O.N. 628114) Dismasting and Fatality
March 25, 2007

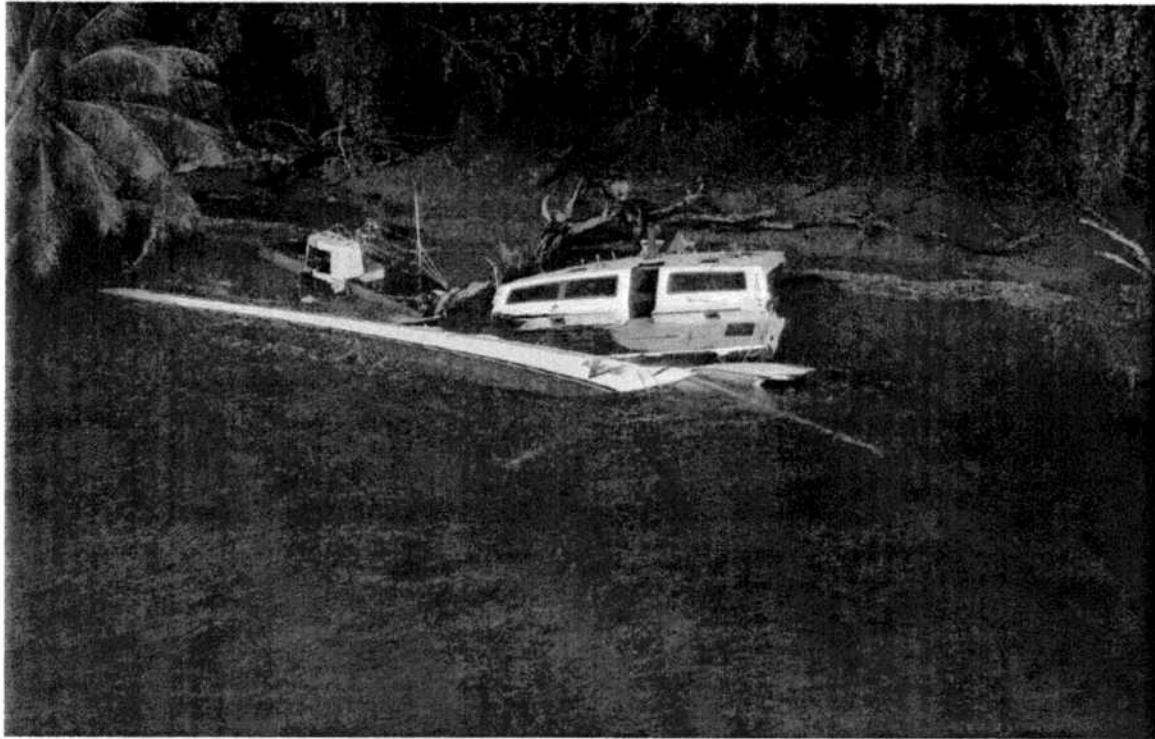
Figure 1: Wreckage of the KIELE V that washed ashore on the south east side of Molokai.

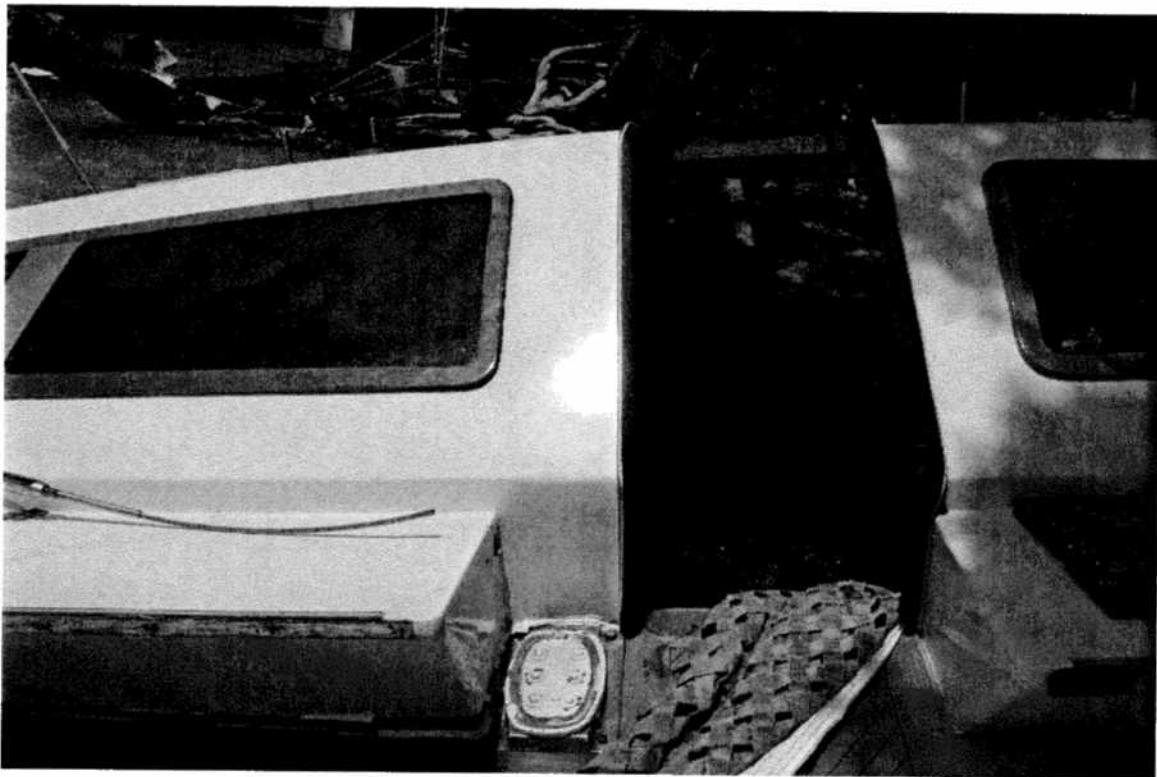
The KIELE V mast step (Figure 2) was recovered from the wreckage that washed ashore on the island of Molokai. Standing rigging, known as shrouds and stays, are tensioned to keep the mast upright. Stays commonly run fore-and-aft along the centerline of the vessel, and shrouds run from the mast to the sides of the vessel. The mast step supports the base, or heel, of the mast, and is comprised of an aluminum base bolted to a stainless steel plate via six stainless steel bolts. The aluminum portion of the mast step had a welded collar, or lip, which is a protrusion that fits up inside the base of the aluminum mast. Post-accident analysis revealed that the KIELE V mast step collar was completely sheared-off during the dismasting, and was not recovered in the wreckage. However, the remainder of the mast step, which included the stainless steel base plate, was still attached to the vessel via four stainless steel fasteners (Figure 3). Two of the fasteners were four inch long lag bolts that were screwed into the vessel's wooden structure. The other two fasteners were five and a half inch bolts that were passed through the vessel's wooden structure and fastened via a nut, lock-washer, and flat washer in the void beneath the mast step mounting plate.

Figure 2: Wreckage of the KIELE V, showing the attached mast step.

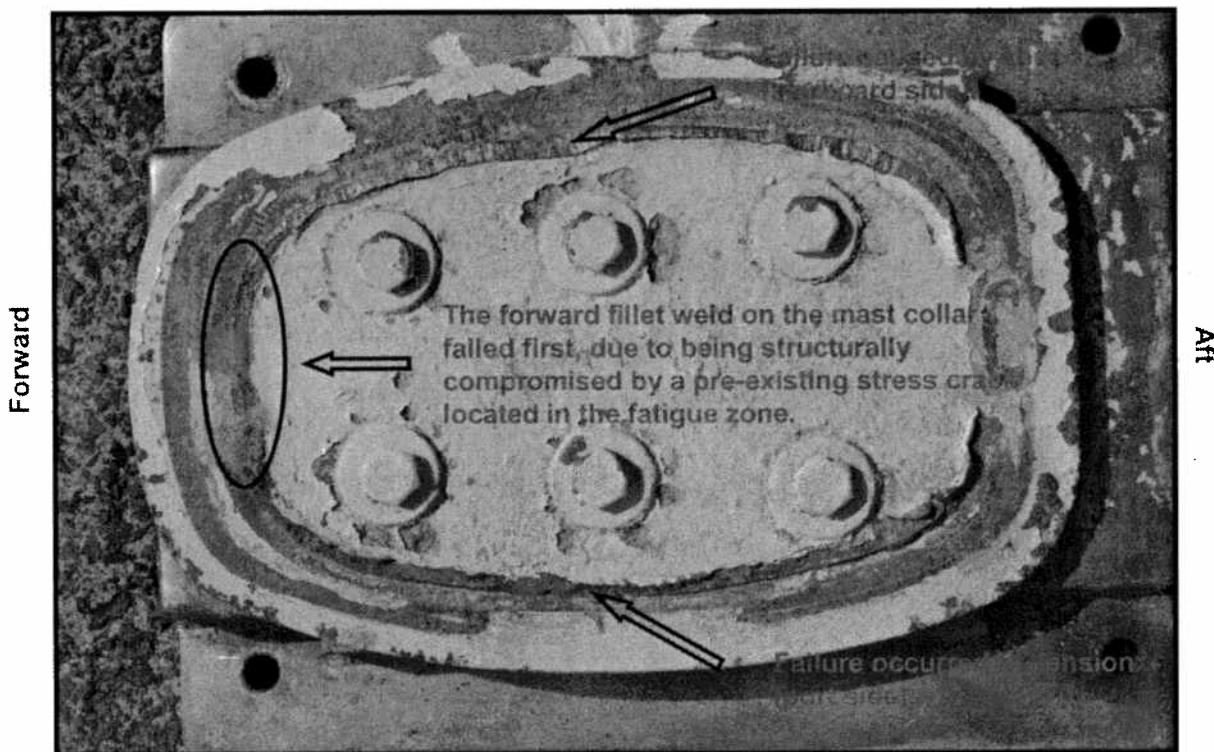
The mast step recovered from the wreckage of the KIELE V was sent to Northwest Laboratories, Inc., in Seattle, WA for metallurgical examination. Mr. [REDACTED], M.S.E. and Forensic Engineer/Technical Director of Northwest Laboratories, conducted an examination of the submitted mast step by means of an optical stereomicroscope (up to 40 x magnification), and a Scanning Electron Microscope (SEM). The fractographic examination revealed the mast step failure to have originated at the forward position of the mast step. The port side of the mast step, at the nine o'clock position, was arbitrarily chosen as the zero degree position. A fatigue zone was found to extend between the 70°-110° position, on the forward portion of the mast step in the fillet weld connecting the aluminum base to the mast step's collar. The remainder of the weld failure was catastrophic in nature, which would indicate that the failure was created by a sudden overload. The failure at the 290°-70° location (port side of the vessel) was the result of tension, while the failure between the 110°-250° location (starboard side of the vessel) was the result of shear. A section containing the entire fatigue zone was removed and further examined. This fractographic examination confirmed the initial failure of the mast

step to be the result of a stress crack that originated at approximately the 80° position. The stress crack initiated at the root of the fillet weld located on the inside of the mast collar, and then spread across the weld throat. Some corrosion pitting in the stress crack was observed, indicating that the crack was present for an undetermined amount of time before the dismasting.

Figure 3: Close up of the KIELE V mast step.

weather conditions on the day of the incident. In this case, the vessel was headed downwind on a port tack, which would have subjected the collar of the mast step to counter-clockwise torsional loading. Assuming the collar of the mast step already was in a weakened state due to the existence of a stress crack, the mast step may have failed first, resulting in the mast foot being forced over the starboard side of the vessel by the compression force of the wind and rigging. As soon as the base of the mast came free, the mast column would naturally fall off to the side opposite of the prevailing winds. Unfortunately, without additional evidence, further information on the cause of the dismasting was not determined during this investigation.

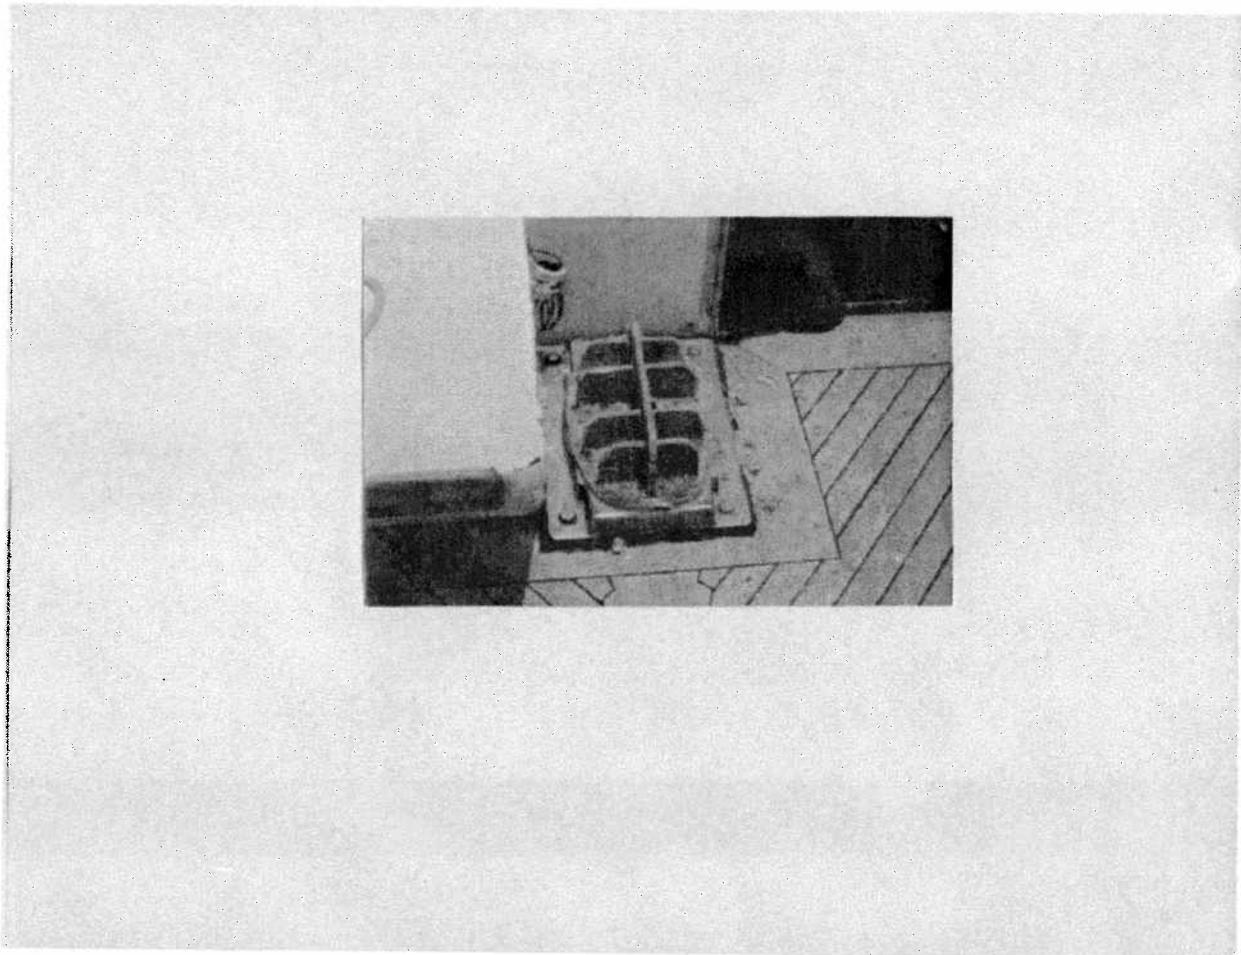
- Investigation did note that the design of the mast step that was in use since 1996 did not include any internal strengthening; such as the lattice framing that was incorporated in the mast step that was in use prior to the 1996 dismasting (See Figure 4). In addition, the master reported that the existing mast step extended up into the base of the mast approximately 8-12 inches. Due to the reported height of this mast collar, if there were any contact areas between the inside of the mast column and the

mast collar, the attachment point of the collar to the mast step may have been subjected to increased fore and aft loading.

Figure 4: Shows additional ribbing used to structurally strengthen the mast step collar. (This mast step was replaced after the KIELE V dismasting incident in April of 1996)
