# UNITED STATES COAST GUARD

## INVESTIGATION INTO THE S/V NAHOKU II DISMASTING AND FATALITY

ON 12/01/2006

MISLE ACTIVITY NUMBER: 2833864

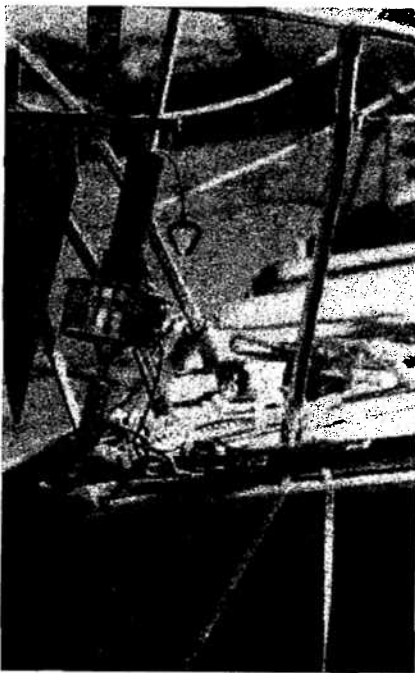
Figure 4 - View of an installed jib furler

Since commercially available furling systems for mainsails do not eliminate the boom, the NAHOKU II owner decided to use a Harken, Inc. jib furling system that was awkwardly attached to the mast and used improperly as a mainsail furler. Enclosure (3).
